FIRE SAFETY FOLLOW UP INSPECTION

Factory Name	Eve Dress Shirt Limited		Factory ID	11346
Address	Anowar Jung Road, Holding #219, Ward # 05, Block #A, Ashulia, Savar , Ashulia, Savar.			
Initial Inspection Date	31-Mar-2014		Report Received Date	
Date of 1st Follow-up	15-Nov-2015	Date of 2nd Follow-up	21-Mar-2016	
Date of 3rd Follow-up	13-Mar-2017	Date of 4th Follow-up	18-Jun-2017	
Date of 5th Follow-up	28-Sep-2017	Date of 6th Follow-up	14-Nov-2017	
Date of 7th Follow-up	14-Mar-2018	Date of 8th Follow-up	22-May-2018	
Date of 9th Follow-up	05-Mar-2019	Date of 10th Follow-up	06-Sep-2020	
Date of 11th Follow-up	31-Aug-2022	Date of 12th Follow-up		
Date of 13th Follow-up		Date of 14th Follow-up		
Date of 15th Follow-up		Date of 16th Follow-up		
Date of 17th Follow-up		Date of 18th Follow-up		
Date of 19th Follow-up		Date of 20th Follow-up		
Inspected by	Nirmal Chandra Sinha

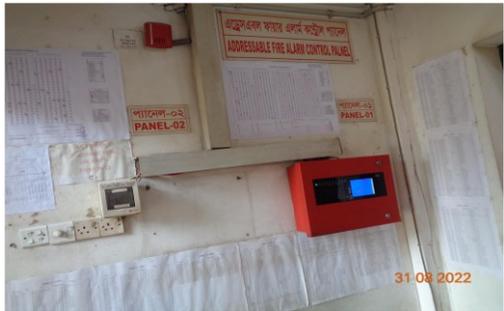
Item No	Inspection Observation	Inspection Recommendation	Timeline given	Comments after Physical Inspection	Supposed to complete (DD/MM/YYYY)	Final Action Plan (Factory)	Status on the date of Inspection	Pictorial Evidence
1	Panel power, zone light (to address zone of alarm), fault light (if anything is disconnected, etc.) on fire alarm control panel are functional for the Main Production building. There is no fire alarm and detection system for the utility building.	Install an automatic fire alarm and detection system for the utility building or expand the existing system. System shall comply with the Alliance Standard and NFPA 72. Consult a qualified fire protection engineer and/or authorized fire alarm company to design and install the system.	Jul 9 2014	<p>On 5-3-2019: Observations are not limited to,</p> <ul style="list-style-type: none"> *Circuit breaker was not marked & open locked *Primary power feed line information was not posted near the panel. *Field devices (Pull stations, detectors) are not secured due to wiring connection. * Interfacing of fire pump controls was not as per Accord requirements. (Electric: Phase Loss, Phase Reversal, Motor Run; Diesel: Controllor Mode, Common trouble) and authentic 3rd party certified/listed cable shall be used. *Pump run signal needs to be supervisory type. * Modules were placed inside Pull station boxes. * MCP location at 6th floor (North-West corner exit) was not visible (obstructed by door). * Detector was missing at roof landing and detector coverage shall be ensured for all locations. <p>On 06/09/2020 (RSC): FADS is ready for full T&CVI. On 23/02/2021: According to T&CVI system is not approved. For details see report. Comment by RCH: On 7/7/22 Factory asked for timeline extension which is not acceptable</p> <p>On 31/08/2022: Fire Alarm and Detection system (FADS) modification work is almost completed according to the factory management and will apply for T&CVI within 2 weeks.</p>	31-Dec-2016	Detection & Protection system in inter connected and we are in the following situation. We were in loop to get more gas use permission from Titas Gas, a government own gas supplier company and just days ago we got the re-connection for more gas and this connection we need to run our	In Progress

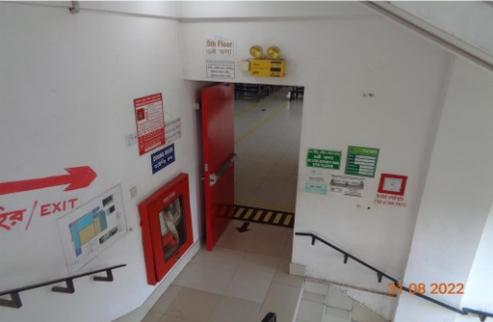
Item No	Inspection Observation	Inspection Recommendation	Timeline given	Comments after Physical Inspection	Supposed to complete (DD/MM/YYYY)	Final Action Plan (Factory)	Status on the date of Inspection	Pictorial Evidence
2	Door widths are more than 0.8m, but doors along the path of egress (i.e. doors leading to staircase) in buildings are not fire doors.	Replace non-compliant doors and frames in the means of egress with side-swinging doors. Replacement doors shall be a minimum width of 0.8 m (32 in), and are listed, approved, self-closing, fire rated doors assemblies (door and frame) with latching panic hardware.	Sep 3 2014	<p>On 28/09/2017: Corrected.</p> <p>On 14/11/2017: Corrected</p> <p>On 14/03/2018: Corrected as per previous follow ups.</p> <p>Smoke seal is missing in several door.</p> <p>On 22/05/2018: Corrected as per previous follow ups.</p> <p>Smoke seal is missing in several doors.</p> <p>On 5-3-2019: Corrected.</p> <p>On 06/09/2020 (RSC): Corrected.</p> <p>On 31/08/2022: Corrected. Replaced.</p>	20-May-2016	Corrected. Fire Door installation (2nd phase) completed.	Corrected

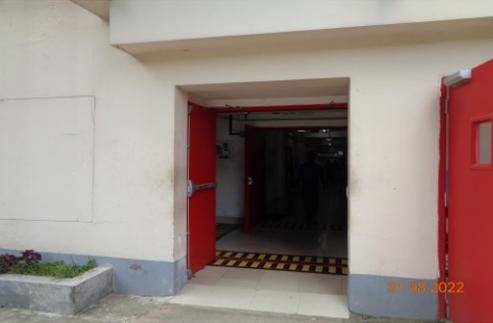
3	There are collapsible doors, rolling shutter & glass swinging doors with locking arrangement at each egress locations.	Replace all non-compliant doors and frames in the means of egress with doors that are listed, approved, automatic-closing, side-swinging, fire rated doors in compatible fire rated frames with latching panic hardware.	Sep 3 2014	<p>On 28/09/2017: Corrected.</p> <p>On 14/11/2017: Corrected</p> <p>On 14/03/2018: Corrected as per previous follow ups.</p> <p>On 22/05/2018: Corrected as per previous follow ups.</p> <p>On 5-3-2019: Corrected.</p> <p>On 06/09/2020 (RSC): Corrected.</p> <p>On 31/08/2022: Corrected. Replaced.</p>	28-Apr-2016	Corrected	Corrected

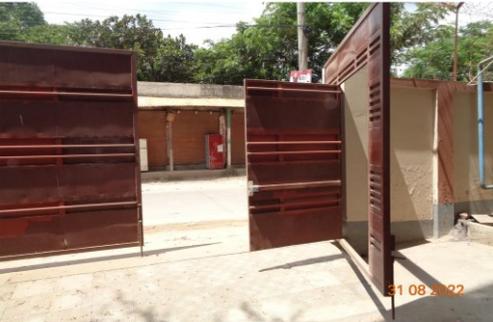
4	There are collapsible doors with locking arrangements at each egress locations.	Remove all hasps, locks, slide bolts, or other locking devices at the noted locations.	Jul 9 2014	<p>On 14/11/2017: Corrected</p> <p>On 14/03/2018: Corrected as per previous follow ups. Shall be removed where exist.</p> <p>On 22/05/2018: Corrected as per previous follow ups.</p> <p>On 5-3-2019: Corrected.</p> <p>On 06/09/2020 (RSC): Corrected.</p> <p>On 31/08/2022: Corrected. Removed and not observed during follow-up inspection.</p>	24-Mar-2016	Corrected	Corrected

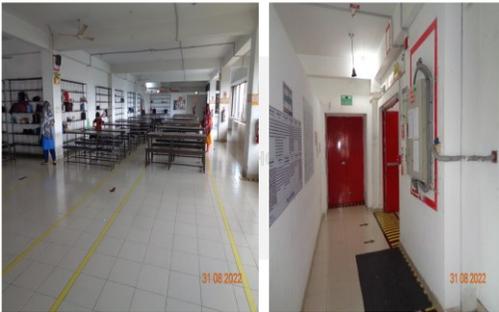
Item No	Inspection Observation	Inspection Recommendation	Timeline given	Comments after Physical Inspection	Supposed to complete (DD/MM/YYYY)	Final Action Plan (Factory)	Status on the date of Inspection	Pictorial Evidence
5	Doors & windows of Bonded warehouse at ground floor, Chemical room and Spot removing room at 2nd floor, Bonded warehouse at 3rd floor, spot removing room at 4th floor, dining hall at 5th floor are not fire separated.	Provide fire-resistive rated opening or penetration protection for rated walls and assemblies in accordance with Alliance Standard Sections 4.6 and 4.7. Consult a qualified fire protection engineer to design the required opening protectives or penetration systems. If the openings are not required, enclose them with the proper fire rating.	Sep 3 2014	<p>On 28/09/2017: Corrected.</p> <p>On 14/11/2017: Corrected</p> <p>On 14/03/2018: Corrected as per previous follow ups. Smoke seal is missing in several door.</p> <p>On 22/05/2018: Corrected as per previous follow ups.</p> <p>On 5-3-2019: Corrected as per previous follow-up. Note: Factory shall seal window opening with floor at Accessories store.</p> <p>On 06/09/2020 (RSC): Corrected.</p> <p>On 31/08/2022: Corrected. Separated.</p>	05-May-2016	Corrected	Corrected

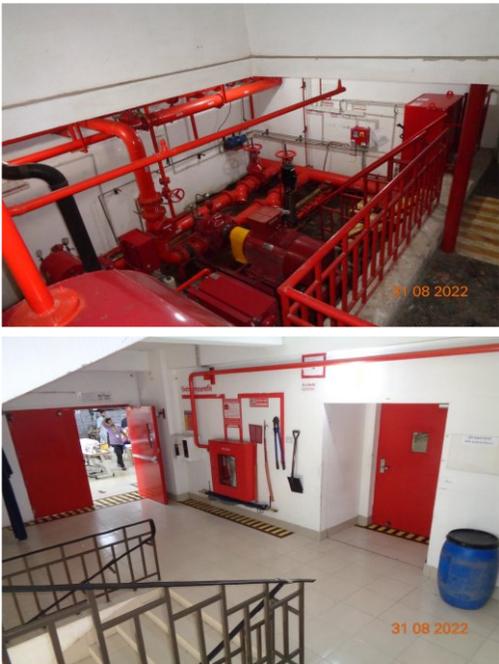
6	There is no stand pipe system in the main and ancillary buildings meeting the requirement of NFPA 14, 20, 22 and 25. No Class-I standpipe hose connection (65 mm) are installed at stairwells in each floor level including occupiable roof. 25 mm plastic hoses are connected with over head water reservoir. At roof hose pressure was negligible. Hose size, pressure and water capacity are not sufficient.	Install standpipe system at required locations. Standpipe system must comply with NFPA 14.	Sep 3 2014	<p>On 22/05/2018: Reportedly modification work is going on.</p> <p>On 5-3-2019: Observations are not limited to, *A listed check valve is missing next to fire brigade connection. *Flow detectors are missing at standpipe risers. * Ball valve was initially found closed at top most of remote riser.</p> <p>On 06/09/2020 (RSC): Installation complete but factory is not ready for full T&CVI due to some reasons as noted in the Pre-T&CVI report. Comment by RCH: On 7/7/22 Factory asked for timeline extension which is not acceptable</p> <p>On 31/08/2022: Standpipe system (Standpipe, Fire Pump and Water Supply system) work is almost completed according to the factory management and will apply for T&CVI within 2 weeks.</p>	15-Sep-2016	Detection & Protection system in inter connected and we are in the following situation. We were in loop to get more gas use permission from Titas Gas, a government own gas supplier company and just days ago we got the re-connection for more gas and this connection we need to run our generator for power generation. As the	In Progress

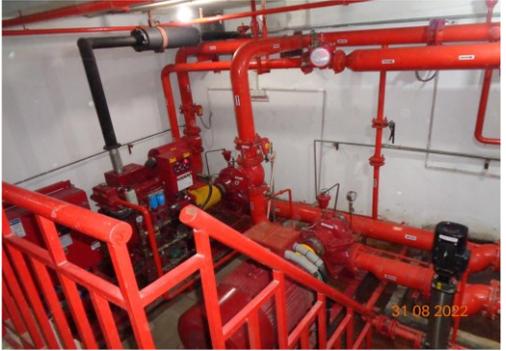
Item No	Inspection Observation	Inspection Recommendation	Timeline given	Comments after Physical Inspection	Supposed to complete (DD/MM/YYYY)	Final Action Plan (Factory)	Status on the date of Inspection	Pictorial Evidence
7	There is no fire pump in the factory premises to supply water in case of fire incidence. Water is supplied to standpipe system from over head water tank.	Install a dedicated fire pump for the facility in accordance with NFPA 20 to supply the demands of the connected fire protection systems along with a stored source of water sufficient to meet the demands in accordance with NFPA 22. Fire pump installation is to be tested for final acceptance in presence of Alliance and a final inspection of the installation shall be conducted by the Alliance prior to final acceptance of the installation by the Alliance as per clause 5.5.5. Acceptance testing of the installation shall be in accordance with NFPA 20, 22, and 25 testing requirements. Documentation of all testing shall be submitted to the Alliance for review prior to final acceptance by the Alliance. This pump is to be connected to alternative power source like generator. And the generator is to be connected with ATS (auto starter).	Sep 3 2014	<p>On 22/05/2018: Refer to issue no 6.</p> <p>On 5-3-2019: Observations are not limited to, *Pressure sensing lines shall be stainless steel type, ball valve located, Pressure sensing line and fuel lines shall be as per NFPA 20. *Suction pressure drops below '-3' psi while the pump runs beyond 100% of its rated capacity. *Cx report provided for fire pump was outdated. An updated report shall be obtained. * Suction header pipe diameter shall be as per NFPA 20 for pumps designed to operate together. * No document was provided for anti-vortex plate. * Water level indicator was not provided.</p> <p>On 06/09/2020 (RSC): Installation complete but factory is not ready for full T&CVI due to some reasons as noted in the Pre-T&CVI report.</p> <p>Comment by RCH: On 7/7/22 Factory asked for timeline extension which is not acceptable.</p> <p>On 31/08/2022: Standpipe system (Standpipe, Fire Pump and Water Supply system) work is almost completed according to the factory management and will apply for T&CVI within 2weeks.</p>	15-Sep-2016	Detection & Protection system in inter connected and we are in the following situation. We were in loop to get more gas use permission from Titas Gas, a government own gas supplier company and just days ago we got the re-connection for more gas and this connection we need to run our generator for power generation	In Progress

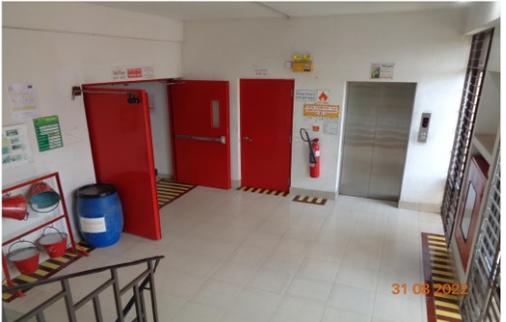
8	There are 3 stairs in the main building and 1 stair at utility building which is under construction. None of the stairs are provided with fire-rated construction. No fire door fitted at exits of any floor.	Provide 2 hr fire-resistive rated construction barriers at exit enclosures. Fit outward opening, side-swinging, self-closing, non-lockable fire doors of 1.5 hr rating in all stairwell enclosures. Consult a qualified fire protection engineer to design the required rated construction barriers.	Sep 3 2014	<p>On 14/11/2017: Corrected</p> <p>On 14/03/2018: Corrected as on previous follow up.</p> <p>On 22/05/2018: Corrected as on previous follow up.</p> <p>On 5-3-2019: Corrected.</p> <p>On 06/09/2020 (RSC): Corrected. Interfacing of fire rated doors were found proper during inspection.</p> <p>On 31/08/2022: Corrected.</p>	21-Mar-2016	Corrected. Fire Door installation (2nd phase) completed.	Corrected

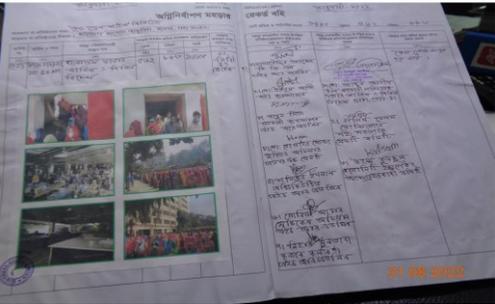
Item No	Inspection Observation	Inspection Recommendation	Timeline given	Comments after Physical Inspection	Supposed to complete (DD/MM/YYYY)	Final Action Plan (Factory)	Status on the date of Inspection	Pictorial Evidence
12	Fire drill is conducted once a month but not under the direction of a Fire Safety Director.	Fire drills shall be conducted under the direction of a Fire Safety Director. All other requirements for fire drills shall be conducted in accordance with BNBC Part 4 Appendix A.	Jul 9 2014	On 14/11/2017: Corrected On 14/03/2018: Corrected as on previous follow ups. On 22/05/2018: Corrected as on previous follow ups. On 5-3-2019: Corrected. On 06/09/2020 (RSC): Corrected. On 31/08/2022: Corrected.	21-Mar-2016	Corrected	Corrected

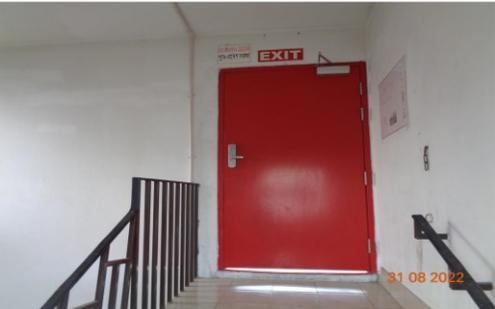
14	The main production building is 7 stories, but doors are not provided with re-entry. Stair doors with re-entry are required in at least 2 floors according to Alliance Standards Part 6 Section 6.8.3.	Provide re-entry to floor levels from the stairwells in accordance with Alliance Standard Section 6.8.3.	Sep 3 2014	On 14/11/2017: Corrected On 14/03/2018: Corrected as on previous follow ups. On 22/05/2018: Corrected as per previous follow ups. On 5-3-2019: Corrected. On 06/09/2020 (RSC): Corrected. On 31/08/2022: Corrected. Provided.	20-Apr-2016	Corrected	Corrected

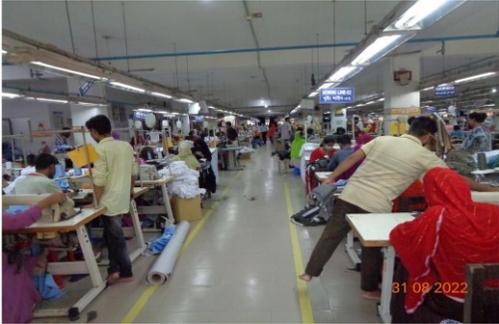
Item No	Inspection Observation	Inspection Recommendation	Timeline given	Comments after Physical Inspection	Supposed to complete (DD/MM/YYYY)	Final Action Plan (Factory)	Status on the date of Inspection	Pictorial Evidence
15	All paths of egress are not provided with compliant means of illumination. Normal CFL lights are used as emergency lights. All stair and main aisles are not illuminated as per the requirement of Alliance standard.	Install appropriate means of illumination at the noted locations. The means of egress paths shall be illuminated at all times the building is occupied. Illumination shall be a minimum of 10 lux for all corridors, exit doors, and stairways. Aisles shall be provided with a minimum 2.5 lux.	Nov 26 2014	On 28/09/2017: Corrected as per previous follow up inspections. Shall be increased in some areas. On 14/11/2017: Corrected On 14/03/2018: Corrected as on previous follow ups. On 22/05/2018: Issue Refer to SL No 42 On 06/09/2020 (RSC): Corrected. On 31/08/2022: Corrected.	21-Mar-2016	Corrected	Corrected

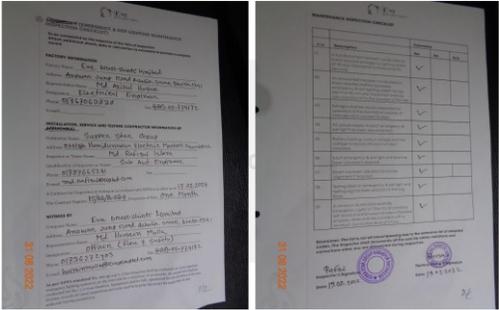
16	Record of verifying emergency illumination was not found as required in accordance with Alliance Standards Part 10 Section 10.12.2.3.	Develop a testing and maintenance program that ensures the operation of all egress lighting is verified at least once per year. If battery-operated lights are used, these lights shall be tested on a monthly basis. Functional testing of battery powered lights shall be provided for a minimum 90 min once per year.	Jul 9 2014	On 14/11/2017: Corrected On 14/03/2018: Corrected as on previous follow ups. On 22/05/2018: Corrected as per previous follow ups. On 5-3-2019: Corrected. On 06/09/2020 (RSC): Corrected. On 31/08/2022: Corrected.	21-Mar-2016	Corrected	Corrected

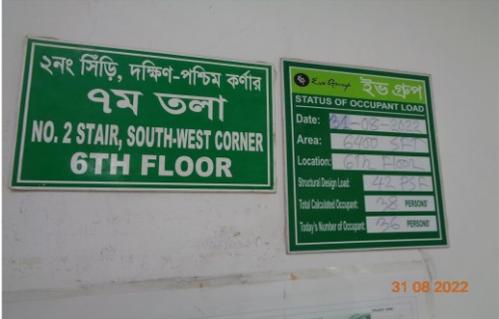
17	Occupant loads are not posted in any assembly and production floor as required by Alliance Standard Part 6 Section 6.4.4.	Post the occupant load for every assembly and production floor in a facility in a conspicuous space near the main exit or exit access doorway for the space.	Jul 9 2014	On 14/11/2017: Corrected On 14/03/2018: Corrected as on previous follow ups. On 22/05/2018: Corrected as per previous follow ups. On 5-3-2019: Corrected. On 06/09/2020 (RSC): Corrected. On 31/08/2022: Corrected as per previous follow up. Occupant loads shall be posted both in Bangla & English.	21-Mar-2016	Corrected	Corrected

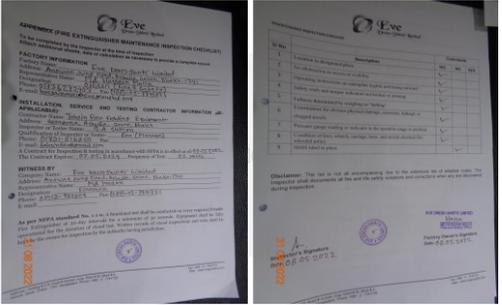
Item No	Inspection Observation	Inspection Recommendation	Timeline given	Comments after Physical Inspection	Supposed to complete (DD/MM/YYYY)	Final Action Plan (Factory)	Status on the date of Inspection	Pictorial Evidence
18	Fire extinguishers are inspected, tested and maintained every month. But no document was found in support of i) annual maintenance of extinguishers by a servicing agent and ii) annual testing of nozzle of CO2 extinguisher. These are required as per NFPA 10.	Establish an inspection, testing, and maintenance program for all fire extinguishers and prepare proper documentation. Program must comply with NFPA 10.	Nov 26 2014	On 28/09/2017: Corrected. On 14/11/2017: Corrected On 14/03/2018: Corrected as on previous follow ups. On 22/05/2018: Corrected as per previous follow ups. On 5-3-2019: Corrected. On 06/09/2020 (RSC): Corrected. On 31/08/2022: Corrected.	21-Mar-2016	Corrected	Corrected

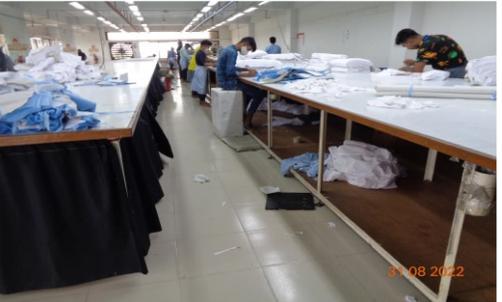
20	Storage areas underneath the cutting tables are not clear of combustibles.	Remove all combustibles stored underneath the cutting tables at the noted locations.	Jul 9 2014	On 14/11/2017: Corrected On 14/03/2018: Corrected as on previous follow ups. On 22/05/2018: Corrected as per previous follow ups. On 5-3-2019: Corrected. On 06/09/2020 (RSC): Corrected. On 31/08/2022: Corrected as per previous follow up.	21-Mar-2016	Corrected	Corrected

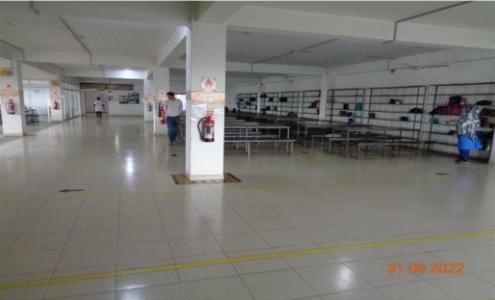
Item No	Inspection Observation	Inspection Recommendation	Timeline given	Comments after Physical Inspection	Supposed to complete (DD/MM/YYYY)	Final Action Plan (Factory)	Status on the date of Inspection	Pictorial Evidence
21	Fabric storage with high glass & dining at 5th floor are not separated by fire-resistive rated construction barriers.	Provide fire-resistive rated construction barriers between hazard types in accordance with Alliance Standard Sections 3.4 and 4.5. Consult a qualified fire protection engineer to design the required rated construction barrier.	Nov 26 2014	On 14/11/2017: Corrected On 14/03/2018: Corrected as on previous follow ups. On 22/05/2018: Corrected as per previous follow ups. On 5-3-2019: Corrected as per previous follow-up. On 06/09/2020 (RSC): Corrected. On 31/08/2022: Corrected.	21-Mar-2016	Corrected	Corrected

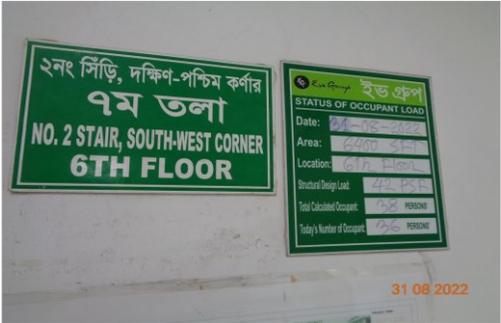
28	Floor level and stair designation signs are not provided at any floor in required locations.	Install signage adjacent to each stair door indicating the stair name and the floor level in English and Bengali at the noted locations.	Jul 9 2014	On 14/11/2017: Corrected On 14/03/2018: Corrected as on previous follow ups. On 22/05/2018: Corrected as per previous follow ups. On 5-3-2019: Corrected. On 06/09/2020 (RSC): Corrected. On 31/08/2022: Corrected.	21-Mar-2016	Corrected	Corrected

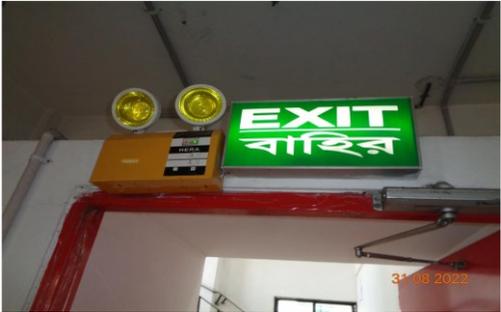
31	New Finding: Manual on-off switch is provided for [emergency lighting / exit signage] units.	Remove manual on/off switches from emergency lighting / exit signage units to prevent them from being switched off.		<p>On 28/09/2017: Corrected as per previous follow up inspections.</p> <p>On 14/11/2017: Corrected</p> <p>On 14/03/2018: Corrected as on previous follow ups.</p> <p>On 22/05/2018: Corrected as per previous follow ups.</p> <p>On 5-3-2019: Corrected.</p> <p>On 06/09/2020 (RSC): Corrected.</p> <p>On 31/08/2022: Corrected. Removed.</p>	30-Apr-2016	Corrected	Corrected

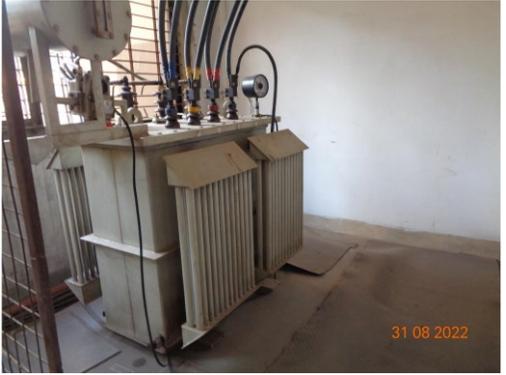
Item No	Inspection Observation	Inspection Recommendation	Timeline given	Comments after Physical Inspection	Supposed to complete (DD/MM/YYYY)	Final Action Plan (Factory)	Status on the date of Inspection	Pictorial Evidence
32	New Finding: Transformer is not properly separated by fire rated construction with other Occupancies/Areas.	<p>1. For Non high-rise building: Oil filled transformer shall be separated from other occupancies by a minimum 2-hr fire rated construction (wall, floor, slab etc.). Switch gears and transformer bays shall be separately housed with a 2-hr rated wll in between. Seal all penetrations and openings (door, window etc.) should be protected by 1.5-hr fire rated materials to maintain the fire separation if required. All exhaust systems shall discharge to the exterior of the building in a safe location.</p> <p>2. For high-rise building: Oil filled transformer shall be separated from other occupancies by a minimum 4-hr fire rated construction (wall, floor, slab etc.). Switch gears and transformer bays shall be separately housed with a 4-hr rated wll in between. Seal all penetrations and openings (door, window etc.) should be protected by 2-hr fire rated materials to maintain the fire separation if required. All exhaust systems shall discharge to the exterior of the building in a safe location.</p> <p>3. Oil filled transformers shall not be housed above ground level Or Relocate it to exterior of the building and maintain a minimum 3m (10 ft.) spatial separation distance from the building.</p>		<p>On 14/11/2017: Corrected On 14/03/2018: Corrected as on previous follow ups. On 22/05/2018: Corrected as per previous follow ups. On 5-3-2019: Corrected. On 06/09/2020 (RSC): Corrected.</p> <p>On 31/08/2022: Corrected.</p>	20-Apr-2016	Corrected	Corrected

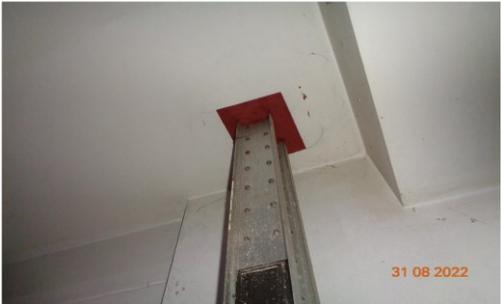
35	New Finding: Penetrations through floor/ceiling assemblies are found unsealed.	<p>Seal all penetrations and openings in floor/ceiling (full thickness of the floor/ceiling) assemblies by fire rated materials to maintain the fire resistance rating.</p> <p>Provide a minimum 2-hr fire rated shaft to separate the utility risers from each floor if required.</p>		<p>On 14/11/2017: Corrected</p> <p>On 14/03/2018: Re-opened as penetrations are not sealed properly.</p> <p>On 22/05/2018: Same as like before. Manufacturing documents could not provide during inspection.</p> <p>On 5-3-2019: Penetrations due to standpipe risers need to be sealed.</p> <p>On 06/09/2020 (RSC): Corrected. Sealed.</p> <p>On 31/08/2022: Corrected.</p>	30-Oct-2016	Corrected	Corrected

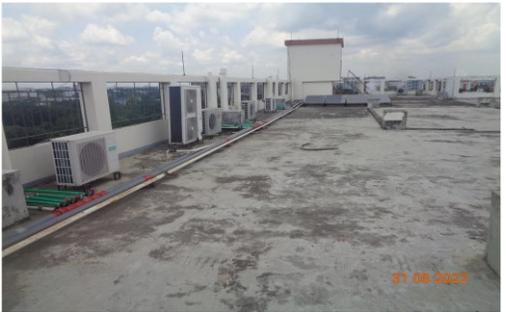
Item No	Inspection Observation	Inspection Recommendation	Timeline given	Comments after Physical Inspection	Supposed to complete (DD/MM/YYYY)	Final Action Plan (Factory)	Status on the date of Inspection	Pictorial Evidence
37	New Finding(2nd Follow-Up): Parapets or guards are not provide at required height in occupiable roof.	Provide parapets or guards with a minimum height of 1067mm (42 inch.).		On 14/11/2017: Corrected On 14/03/2018: Corrected as on previous follow ups. On 22/05/2018: Corrected as per previous follow ups. On 5-3-2019: Corrected. On 06/09/2020 (RSC): Corrected. Sealed. On 31/08/2022: Corrected. Provided.	30-Jun-2016	Corrected	Corrected

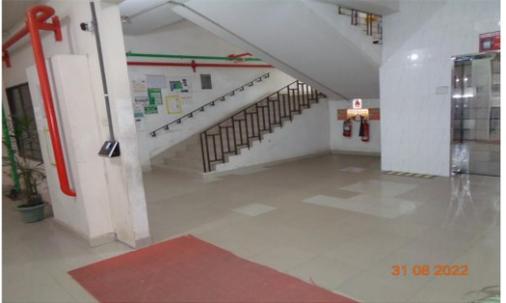
38	New Finding(2nd Follow-Up): Storage was located in the exit stair. Location: Ground Floor.	Remove all storage from exit stairs and egress paths.		On 28/09/2017: Corrected. On 14/11/2017: Corrected On 14/03/2018: Corrected as on previous follow ups. On 22/05/2018: Re-opened as storage were found at exit stair. On 5-3-2019: Corrected. On 06/09/2020 (RSC): Corrected. On 31/08/2022: Corrected. Removed.	04-Apr-2016	Corrected	Corrected

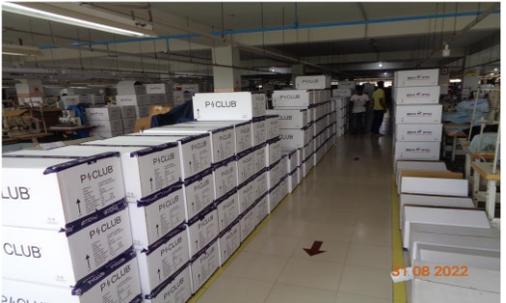
39	New Finding (4th follow): Areas used for in-process storage of combustible materials are open to the surrounding occupancy. Location-	General Condition: Maximum height of 2.4m and maximum area of 23m2. Separate areas of unenclosed combustible storage by a minimum clear distance of 3m.If sprinkler protected: maximum height of 3.66m and maximum area of 93m2. Separate areas of unenclosed combustible storage by a minimum clear distance of 3m.or Enclose the storage area from the surrounding occupancy with a minimum 1 hour construction.	Jul 18 2017	On 14/11/2017: Corrected On 14/03/2018: Corrected as on previous follow up. On 22/05/2018: Re-opened as in process storage were found without maintaining accord standard. On 5-3-2019: Corrected. Within limits. On 06/09/2020 (RSC): Corrected. On 31/08/2022: Issue re-open. Finished goods storage areas were not organised on 4th floor of the building.	18-Jul-2017	Corrected	In Progress

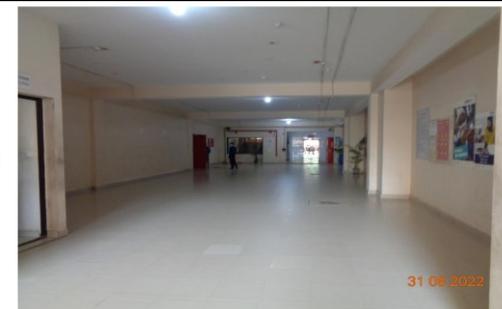
40	New Finding: Exit stair (Middle stair) is discharge the occupants inside the building.	<p>Modify stair to discharge directly outside. Or Provide 2-hr fire-rated exit passageway leading directly outside (vestibules to separate any storage areas). Or Provide sprinkler protection for discharge floor in accordance with NFPA 13.</p>	Within 2 months	<p>On 22/05/2018: Corrected . Note: Discharge path shall keep free from storage & obstruction. On 5-3-2019: Corrected. On 06/09/2020 (RSC): Corrected. On 31/08/2022: Corrected.</p>	14-May-2018	Corrected	Corrected	
----	--	--	-----------------	--	-------------	-----------	-----------	--

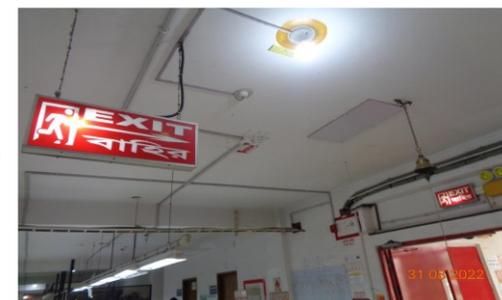
42	New Finding (8th Follow-up): All paths of egress are not provided with compliant means of illumination. Emergency light not illuminated during testing (burned out, broken, etc.).	Maintain adequate illumination at means of egress path as per accord standard & replace burned out/damaged light regularly.	Within 1 month	<p>On 22/05/2018: New Finding. On 5-3-2019: Corrected. On 06/09/2020 (RSC): Corrected. On 31/08/2022: Corrected.</p>	22-Jun-2018	Corrected	Corrected	
----	--	---	----------------	--	-------------	-----------	-----------	--

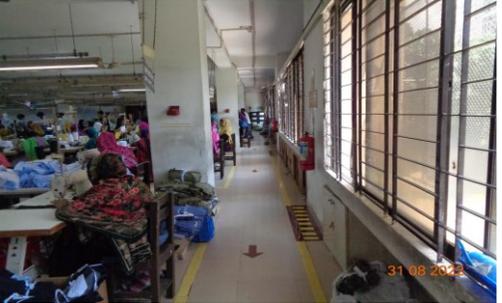
Item No	Inspection Observation	Inspection Recommendation	Timeline given	Comments after Physical Inspection	Supposed to complete (DD/MM/YYYY)	Final Action Plan (Factory)	Status on the date of Inspection	Pictorial Evidence
43	New Finding (8th Follow-up): During the inspection egress aisles were obstructed by combustible storages and available clear width were found less than 36 inch.	Provide aisles free from obstructions and with minimum clear widths of 36-inch.	Immediate	On 22/05/2018: New Finding. On 5-3-2019: Not observed. On 06/09/2020 (RSC): Corrected. During inspection most of the aisles found free from obstruction. On 31/08/2022: Corrected.	12-Jun-2018	Corrected	Corrected
