Fire & Life Safety Follow up Inspection

Factory Name	Eve Dress Shirt Limited		Factory ID	11346	Remarks/Note : The factory is under escalation Stage-1 for T&C process from 15 May 2024.
Address	Anowar Jung Road, Holding #219, Ward # 05, Block #A, Ashulia, Savar , Ashulia, Savar.				
Initial Inspection Date	31 Mar 2014	Initial Report Received Date			
No of Follow-up :	12	Date Of Follow-up Inspection:	09-Dec-2024		
Inspected by	Mahbub Alam Sami

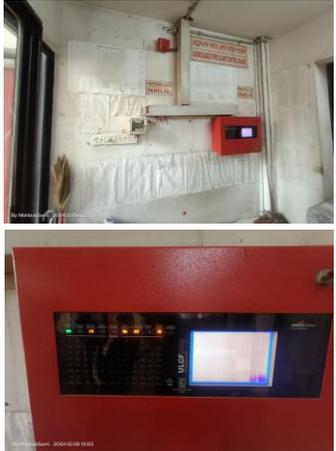
Item No	Issue Type	Issue Sub-Category	Inspection Observation	Inspection Recommendation	Timeline given	Comments after Physical Inspection	Final Timeline	Final Action Plan (Factory)	Status on the date of Inspection	Pictorial Evidence
1	Fire Alarm & Detection System (FADS)	Inadequate fire detection & alarm system	Panel power, zone light (to address zone of alarm), fault light (if anything is disconnected, etc.) on fire alarm control panel are functional for the Main Production building. There is no fire alarm and detection system for the utility building.	Install an automatic fire alarm and detection system for the utility building or expand the existing system. System shall comply with the Alliance Standard and NFPA 72. Consult a qualified fire protection engineer and/or authorized fire alarm company to design and install the system.	Jul 9 2014	<p>On 5-3-2019: Observations are not limited to,*Circuit breaker was not marked & open locked*Primary power feed line information was not posted near the panel.*Field devices (Pull stations, detectors) are not secured due to wiring connection.* Interfacing of fire pump controls was not as per Accord requirements. (Electric: Phase Loss, Phase Reversal, Motor Run; Diesel: Controller Mode, Common trouble) and authentic 3rd party certified/listed cable shall be used.*Pump run signal needs to be supervisory type.* Modules were placed inside Pull station boxes.* MCP location at 6th floor (North-West corner exit) was not visible (obstructed by door).* Detector was missing at roof landing and detector coverage shall be ensured for all locations.</p> <p>On 06/09/2020 (RSC): FADS is ready for full T&CVI.</p> <p>On 23/02/2021: According to T&CVI system is not approved. For details see report.</p> <p>On 31/08/2022: Fire Alarm and Detection system (FADS) modification work is almost completed according to the factory management and will apply for T&CVI within 2 weeks.</p> <p>On 11/05/2023: T&CVI found that the system requires final verification inspection. See detailed T&CVI report.</p> <p>On 09-Dec-24: FADS found active during the inspection. However, there were several trouble and supervisory signals in the FACP as the modifications works was going on. FADS requires a Final Verification as per last conducted T&CVI on 11th May 2023. Reportedly, factory will complete the modifications works and submit the documents for Final Verification by January 2025. Mentionable that, FACP-2 was sent for repairing and not found in the fire control room which serves the Building-3 (Not included in the RSC ID).</p>	31/Dec/2016	While maintenance / checking and rearrangement several issues came up and thus we purchased several new items for chance the existing. And reinstallation is on going.	Pending Verification

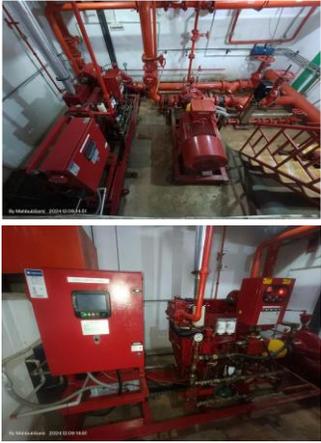
6	Fire Suppression System (SUPS)	Standpipe Design & Installation	There is no stand pipe system in the main and ancillary buildings meeting the requirement of NFPA 14, 20, 22 and 25. No Class-I standpipe hose connection (65 mm) are installed at stairwells in each floor level including occupiable roof. 25 mm plastic hoses are connected with over head water reservoir. At roof hose pressure was negligible. Hose size, pressure and water capacity are not sufficient.	Install standpipe system at required locations. Standpipe system must comply with NFPA 14.	Sep 3 2014	On 22/05/2018: Reportedly modification work is going on. On 5-3-2019: Observations are not limited to,*A listed check valve is missing next to fire brigade connection.*Flow detectors are missing at standpipe risers.* Ball valve was initially found closed at top most of remote riser. On 06/09/2020 (RSC): Installation complete but factory is not ready for full T&CVI due to some reasons as noted in the Pre-T&CVI report. On 31/08/2022: Standpipe system (Standpipe, Fire Pump and Water Supply system) work is almost completed according to the factory management and will apply for T&CVI within 2 weeks. On 01-Apr-2024: Pre-T&C conducted and found the system is not ready for T&CVI and another on-site Pre-T&C is required. See detailed Pre-T&CVI report. On 09-Dec-24: Significant progress has been observed. SUPS found non-functional as the modification work was going on during the inspection. SUPS requires a New-Pre-T&CVI as per last conducted Pre-T&CVI on 1st Apr 2024. Reservoir capacity has increased and feed mains are relocated. Factory will complete the modifications and submit the documents for Pre-T&CVI by January 2025.	15/Sep/2016	Recommended tasks as per RSC are in progress, so far 68% tasks completed.	In Progress

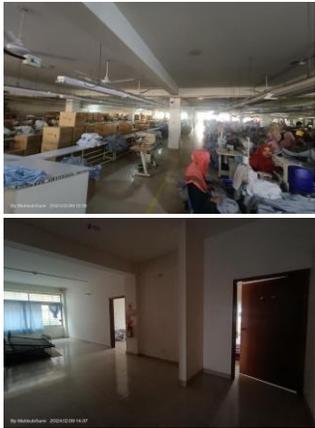
Item No	Issue Type	Issue Sub-Category	Inspection Observation	Inspection Recommendation	Timeline given	Comments after Physical Inspection	Final Timeline	Final Action Plan (Factory)	Status on the date of Inspection	Pictorial Evidence
42	Means of Egress	Egress Lighting	New Finding (8th Follow-up): All paths of egress are not provided with compliant means of illumination. Emergency light not illuminated during testing (burned out, broken, etc.).	Maintain adequate illumination at means of egress path as per accord standard & replace burned out/damaged light regularly.	Within 1 month	On 22/05/2018: New Finding. On 5-3-2019: Corrected. On 06/09/2020 (RSC): Corrected. On 31/08/2022: Corrected. On 09-Dec-24: Re-opened. Inadequate emergency lights have been observed at 4th, 2nd and 1st floor Main Production Building and Utility Building.	22/Jun/2018	Corrected	In Progress
