ELECTRICAL SAFETY FOLLOW UP INSPECTION REPORT (12TH)

Factory Name	Eve Dress Shirt Limited	Remarks (If any):
Address	Anowar Jung Road, Holding #219, Ward # 05, Block #A, Ashulia, Savar , Ashulia, Savar.	
Factory ID	11346	
Date of Initial Inspection	31 Mar 2014	
Date of last FUI	23-Jan-2024	
Date of Current FUI	20-Mar-2025	
Inspected by and Author(s)	Md. Niyaz Ahmed

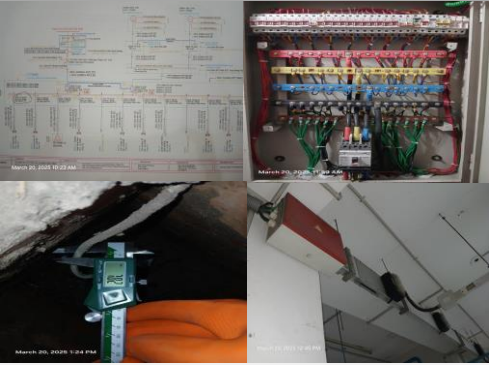
Item No	Inspection Observation	Inspection Action Plan (Recommendation)	Inspection Timeline (given in report)	Inspection Comments (After Physical Inspection)	Factory Timeline (Approved timeline)	Final Action Plan (Factory)	Progress Status (On the date of inspection)	Pictorial Evidence
54	New Finding: Ambiguity found in thermographic scan report (protector glass was not removed while doing scan for report preparation).	Thermography survey shall be conducted in adequate manner on entire electrical system in the facility at least twice in a year. And the remediation suggestions mentioned in the report shall be carried out.	1 Month	On 05/03/2019: Corrected.	30-Jun-2018		Corrected	
55	New Finding: Field information has no/less reflection in existing SLD.	Draw as built electrical SLD mentioning all required information by qualified engineer and get it reviewed by RSC. Electrical SLD must be updated properly when electrical system is modified.	2 Months	On 23/01/2024: Not Corrected. Some progress has been observed. Factory got their SLD as "Need Minor Modification" from RSC on 18/01/2024. Now, they are preparing SLD to resubmit at RSC with the required correction. On 20/03/2025: Not corrected. Around 60% progress found. Factory received SLD from RSC with a status of "Acceptance" on 4th April 2024. As per accepted and as built SLD, BBT layout information is not included for all floors. Additionally, inadequate earthing has been observed of transformer and generators according to accepted drawing. Factory needs to resubmit SLD to RSC incorporating all previous review comments and all BBT layout information.	31-Oct-2022		In Progress
