Structural Safety Inspection Report

Factory Name	Eve Dress Shirt Limited
Factory ID	11346
Factory Address	Anowar Jung Road, Holding #219, Ward # 05, Block #A, Ashulia, Savar , Ashulia, Savar.
Date of Initial Inspection	10 Apr 2014
Date of Review Inspection	20-Mar-2025
Inspected by	Md. Jahidul Islam

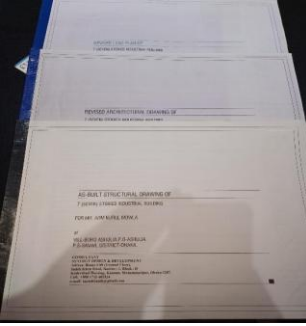
Item No	Inspection Observation	Action Plan from Inspection (Recommendation)	Timeline from Inspection	Final Action Plan from Factory	Final Timeline (dd-mmm-yyyy)	Comments after Physical Inspection	Progress Status	Pictorial Evidence
7	Available structural documents do not indicate conformance with 2006 BNBC or other comparable applicable international model building code. A certification document by the structural engineer & architect states that the building is safe for factory operation according their structural design & construction supervision, but does not mention conformance with the 2006 BNBC or other comparable applicable international model building code.	Engage a qualified structural engineer to develop the required documents to confirm the structural integrity of the buildings. Documents must comply with Alliance Standard Part 8 Section 8.19 and 8.20.	Jun 29 2014	Completed	18-Mar-2015	<p>On 15th Nov-2015: This issue will cover in design report and as build drawing.</p> <p>On 11th Dec-2017: DEA has been accepted from Alliance on 20th June 2017. As per accepted some remediation works (demolition work) were required to be implemented and during inspection it was observed that factory management completed all remediation works except in two toilet areas of 3rd and 6th floor. Factory management must complete all the remediation works.</p> <p>On 25/03/2018: DEA was accepted from ALLIANCE on 20th June 2017. Factory management has completed all remediation work as per suggested DEA.</p> <p>On 20-Feb-2024: Previously corrected.</p> <p>On 20-Mar-2025: Corrected previously.</p>	Corrected

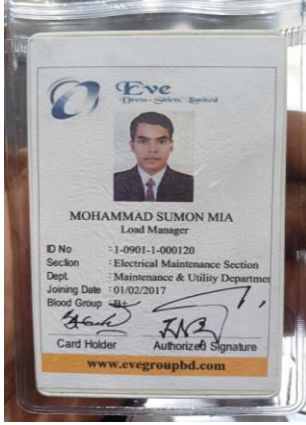
9	There is no designated representative (Factory Load Manager).	Designate a representative as the Factory Load Manager. The Factory Owner shall ensure that at least one individual, the Factory Load Manager who is located onsite full time at the factory, is trained in calculating operational load characteristics of the specific factory. The Factory Load Manager shall serve as an ongoing resource to RMG vendors and be responsible to ensure that the factory operational loads do not at any time exceed the factory floor loading limits as described on the Floor Loading Plans.	Jun 29 2014	Completed (As per Alliance 3rd RVV on 18.07.2016)	08-Jun-2015	<p>On 15th Nov-2015: The factory already engage an load manager.</p> <p>On 11th Dec-2017: This issue was corrected from previous inspection. Load manager has been appointed and he was present during inspection.</p> <p>On 25/03/2018: Corrected from previous follow up inspection. Load manager has been appointed. Load manager is present during inspection.</p> <p>On 20-Feb-2024: Previously corrected. Load manager has been appointed. Load manager is present during inspection.</p> <p>On 20-Mar-2025: Corrected previously. Designated load manager was present.</p>	Corrected

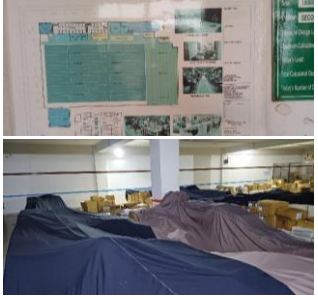
Item No	Inspection Observation	Action Plan from Inspection (Recommendation)	Timeline from Inspection	Final Action Plan from Factory	Final Timeline (dd-mmm-yyyy)	Comments after Physical Inspection	Progress Status	Pictorial Evidence
10	Floor load plan has not been prepared so far, but loading is within 42 psf.	Have a qualified structural engineer develop Floor Loading Plans per the requirements of Part 8 Section 8.20.5.3.	Jun 29 2014	Completed (As per Alliance 3rd RVV on 18.07.2016)	18-Mar-2015	<p>On 15th Nov-2015: load plans were not produced yet but they maintain loading 2kpa except store area in 5th & 3rd floor. Up to finalize design report the factory should be maintain 2kpa.</p> <p>On 11th Dec-2017: Load plan has been produced as part of DEA and accepted from Alliance.</p> <p>On 25/03/2018: Corrected from previous follow up inspection. Load plan was produced as part of DEA which was accepted by ALLIANCE.</p> <p>On 20-Feb-2024: Previously corrected. Load plan is found posted on floors and loading limit signage is observed and loading found as per accepted load plan (2kPa).</p> <p>On 20-Mar-2025: Corrected previously. During the inspection, load plan was found posted on the floors and loading was found within the allowable limit of the accepted load plan (2 kPa for production area; 3 kPa for store area).</p>	Corrected

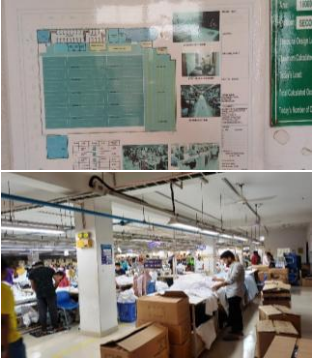
11	No floor load plans have been developed.	Have a qualified structural engineer prepare load plans including the information required in Section 8.20 of the Alliance Standard. Floor load plans should be displayed on all levels of the building.	Jun 29 2014	Completed	07-Apr-2015	<p>On 15th Nov-2015: load plans were not produced yet but they maintain loading 2kpa except store area in 5th & 3rd floor. Up to finalize design report the factory should be maintain 2kpa.</p> <p>On 11th Dec-2017: During inspection load plan was found posted in every floor plate and load was observed below allowable limit. Final load plan shall be implemented after completion of the remediation works.</p> <p>On 25/03/2018: Load plan was produced as part of DEA which was accepted by ALLIANCE. During inspection, load plan is found posted in every floor and load was observed below allowable limit. Factory management has completed all remediation work as per suggested DEA.</p> <p>On 20-Feb-2024: Previously corrected. Load plan is found posted on floors and loading limit signage is observed and loading found as per accepted load plan (2kPa).</p> <p>On 20-Mar-2025: Corrected previously. During the inspection, load plan was found posted on the floors and loading was found within the allowable limit of the accepted load plan (2 kPa for production area; 3 kPa for store area).</p>	Corrected
