Structural Safety Inspection Report

Factory Name	Eve Dress Shirt Limited
Factory ID	11346
Factory Address	Anowar Jung Road, Holding #219, Ward # 05, Block #A, Ashulia, Savar , Ashulia, Savar.
Date of Initial Inspection	10 Apr 2014
Date of Review Inspection	20-Feb-2024
Inspected by	Muhsena Tasnim

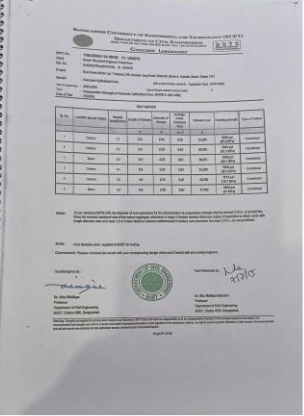
Item No	Inspection Observation	Action Plan from Inspection (Recommendation)	Timeline from Inspection	Final Action Plan from Factory	Final Timeline (dd-mmm-yyyy)	Comments after Physical Inspection	Progress Status	Pictorial Evidence
1	No nondestructive testing of material strength was completed during the initial assessment. Considering 2100psi strength of concrete for MCAC calculated FoS for columns considering vertical loads are adequate, but FoS for central column lies between 1.5 to 1.86 which warrants further investigation. FoS for central column=1.6 FoS for corner column=2.57 FoS for edge column=1.94	Under guidance from a qualified structural engineer arrange additional investigation which will include destructive core testing to verify the concrete compressive strength of columns.	Jun 29 2014	Completed (As per Alliance approved Structural Design Report on 20.06.2017)	07-Mar-2015	On 15th Nov-2015: The factory completed core test work but yet not shown any design calculation on basis of core test result. It should be cover in Design report. On 11th Dec-2017: Cores have been taken and covered in DEA. During inspection all core locations have been found as per test report. On 25/03/2018: Corrected from previous follow up inspection. Cores were taken and tested. On 20-Feb-2024: Previously corrected.	Corrected

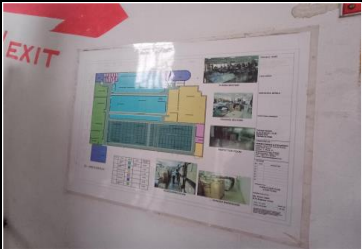
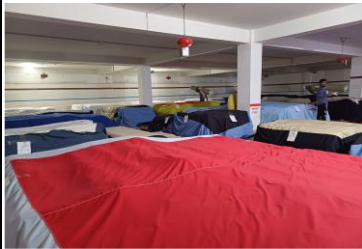
Item No	Inspection Observation	Action Plan from Inspection (Recommendation)	Timeline from Inspection	Final Action Plan from Factory	Final Timeline (dd-mmm-yyyy)	Comments after Physical Inspection	Progress Status	Pictorial Evidence
5	There is no program in place to ensure that the live loads for which a floor or roof is or has been designed will not be exceeded.	Develop a program to ensure that all live loads for which a floor or roof has been designed for will not be exceeded. The designated Load Manager shall oversee this program and ensure it is enforced.	Jun 29 2014	Completed (As per Alliance 3rd RVV on 18.07.2016)	18-Mar-2015	<p>On 15th Nov-2015: load plans were not produced yet. The factory should be include roof top gardening load and each floor additional 10"brick wall for fire door fixing purpose.</p> <p>On 11th Dec-2017: Load plan has been produced as part of DEA and accepted from Alliance. Load manager has also been appointed and he was present during inspection.</p> <p>On 25/03/2018: Corrected from previous follow up inspection. Load plan was produced as part of DEA which was accepted by ALLIANCE. Load manager is appointed. Load plan is observed posted on floors and loading limit signage is observed as per accepted load plan.</p> <p>On 20-Feb-2024: Previously corrected. Load plan is found posted on floors and loading limit signage is observed and loading found as per accepted load plan (2kPa).</p>	Corrected

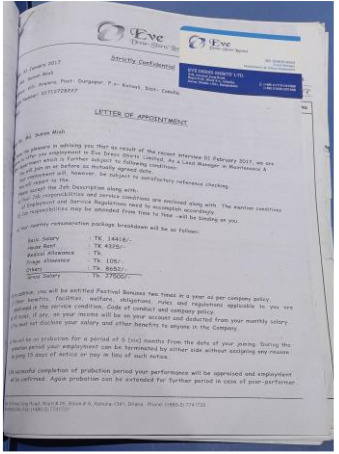
Item No	Inspection Observation	Action Plan from Inspection (Recommendation)	Timeline from Inspection	Final Action Plan from Factory	Final Timeline (dd-mmm-yyyy)	Comments after Physical Inspection	Progress Status	Pictorial Evidence
9	There is no designated representative(Factory Load Manager).	Designate a representative as the Factory Load Manager. The Factory Owner shall ensure that at least one individual, the Factory Load Manager who is located onsite full time at the factory, is trained in calculating operational load characteristics of the specific factory. The Factory Load Manager shall serve as an ongoing resource to RMG vendors and be responsible to ensure that the factory operational loads do not at any time exceed the factory floor loading limits as described on the Floor Loading Plans.	Jun 29 2014	Completed (As per Alliance 3rd RVV on 18.07.2016)	08-Jun-2015	<p>On 15th Nov-2015: The factory already engage a load manager.</p> <p>On 11th Dec-2017: This issue was corrected from previous inspection. Load manager has been appointed and he was present during inspection.</p> <p>On 25/03/2018: Corrected from previous follow up inspection. Load manager has been appointed. Load manager is present during inspection.</p> <p>On 20-Feb-2024: Previously corrected. Load manager has been appointed. Load manager is present during inspection.</p>	Corrected

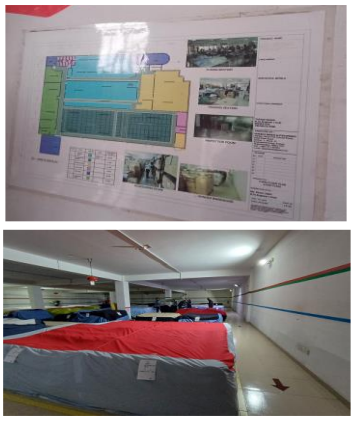
10	Floor load plan has not been prepared so far, but loading is within 42 psf.	Have a qualified structural engineer develop Floor Loading Plans per the requirements of Part 8 Section 8.20.5.3.	Jun 29 2014	Completed (As per Alliance 3rd RVV on 18.07.2016)	18-Mar-2015	<p>On 15th Nov-2015: load plans were not produced yet but they maintain loading 2kpa except store area in 5th & 3rd floor. Up to finalize design report the factory should be maintain 2kpa.</p> <p>On 11th Dec-2017: Load plan has been produced as part of DEA and accepted from Alliance.</p> <p>On 25/03/2018: Corrected from previous follow up inspection. Load plan was produced as part of DEA which was accepted by ALLIANCE.</p> <p>On 20-Feb-2024: Previously corrected. Load plan is found posted on floors and loading limit signage is observed and loading found as per accepted load plan (2kPa).</p>	Corrected

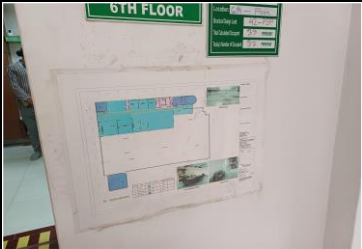
Item No	Inspection Observation	Action Plan from Inspection (Recommendation)	Timeline from Inspection	Final Action Plan from Factory	Final Timeline (dd-mmm-yyyy)	Comments after Physical Inspection	Progress Status	Pictorial Evidence
11	No floor load plans have been developed.	Have a qualified structural engineer prepare load plans including the information required in Section 8.20 of the Alliance Standard. Floor load plans should be displayed on all levels of the building.	Jun 29 2014	Completed	07-Apr-2015	<p>On 15th Nov-2015: load plans were not produced yet but they maintain loading 2kpa except store area in 5th & 3rd floor. Up to finalize design report the factory should be maintain 2kpa.</p> <p>On 11th Dec-2017: During inspection load plan was found posted in every floor plate and load was observed below allowable limit. Final load plan shall be implemented after completion of the remediation works.</p> <p>On 25/03/2018: Load plan was produced as part of DEA which was accepted by ALLIANCE. During inspection, load plan is found posted in every floor and load was observed below allowable limit. Factory management has completed all remediation work as per suggested DEA.</p> <p>On 20-Feb-2024: Previously corrected. Load plan is found posted on floors and loading limit signage is observed and loading found as per accepted load plan (2kPa).</p>	Corrected
